**Proposal: Summer Place Apartments Merritt FL. Exterior Damage Building 200**

**Inspection:** An inspection of building 200 was made and reviewed for this cost proposal.

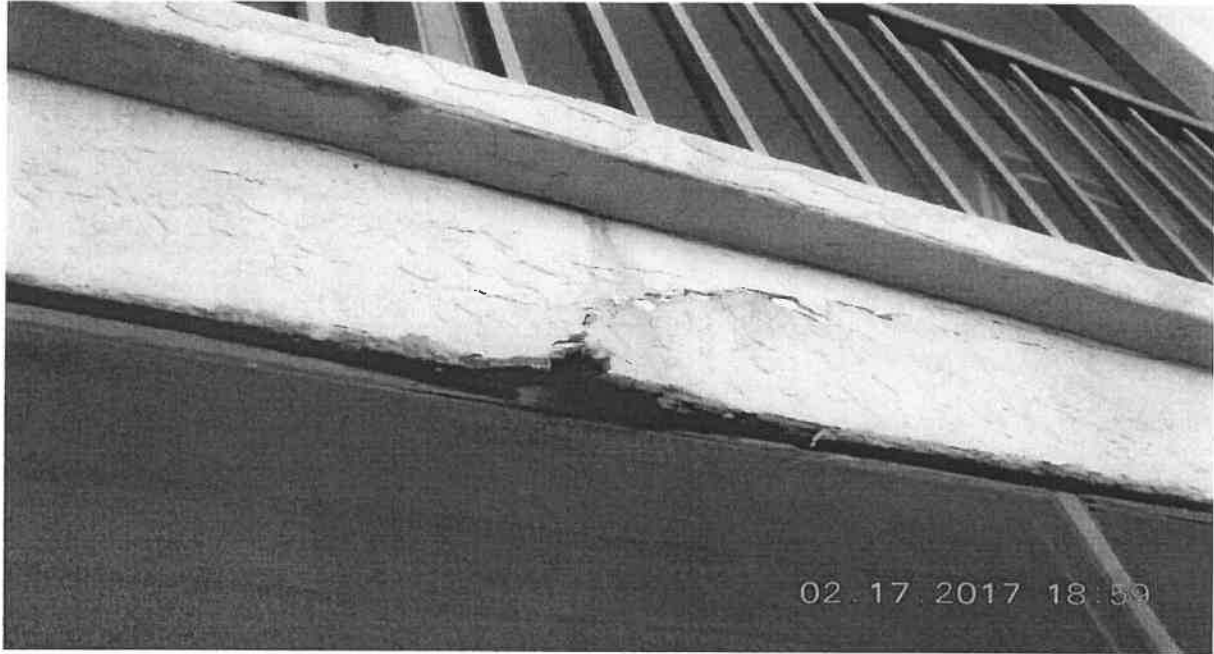
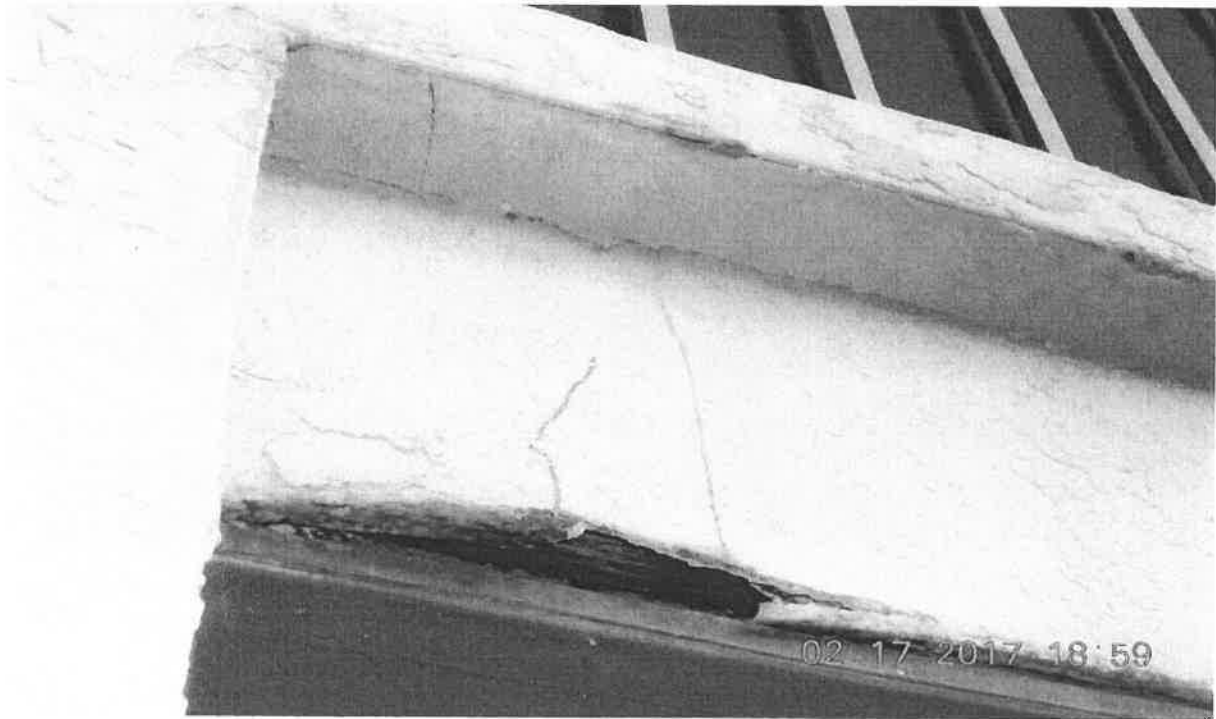
Back porch balcony repairs unit # 7 & 8. This will require installing floor supports on the first floor to support the second during construction. Removing the screen/handrail and stucco cover over the steel bar and chiseling out the cracked concrete on the back porches, after installing temporary barriers on the second floor. Rebuild/replace both balconies concrete approximately 2 feet from the outer edge; this work may require more concrete deck/porch replacement. Finish the work area by reinstalling screen/handrail texturing and painting to match existing as close as possible.

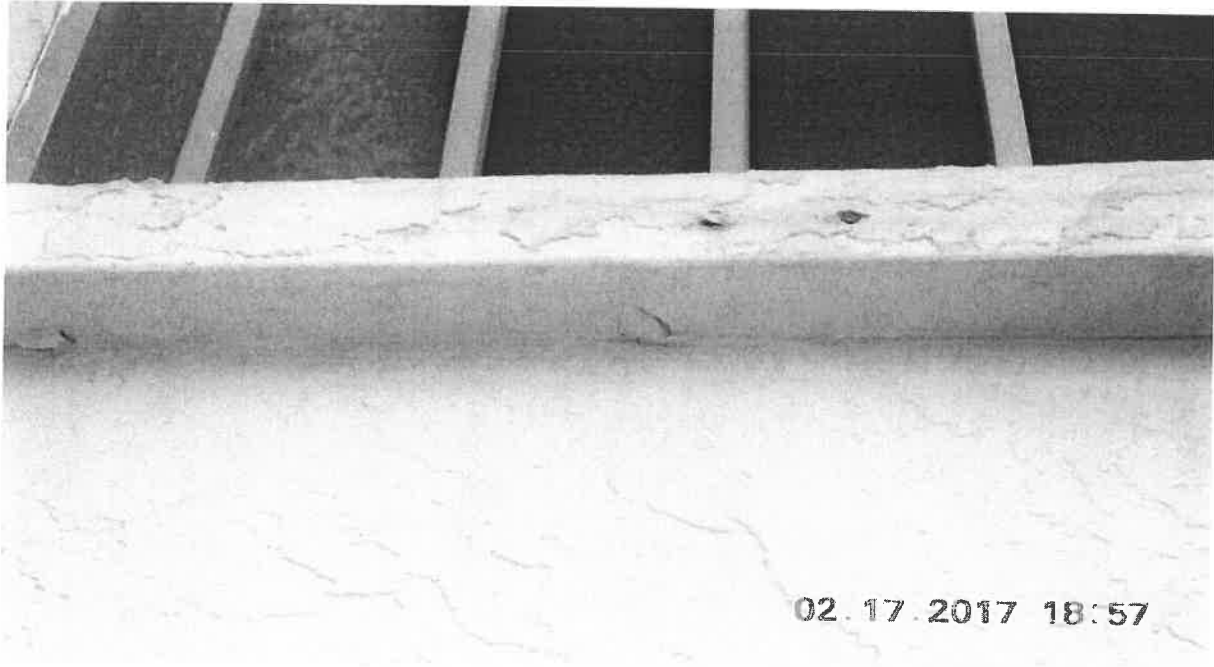
Balcony repair on unit 6 does not appear to be as extensive as unit seven and eight but will require removing the screen supporting the floor below and performing the repairs.

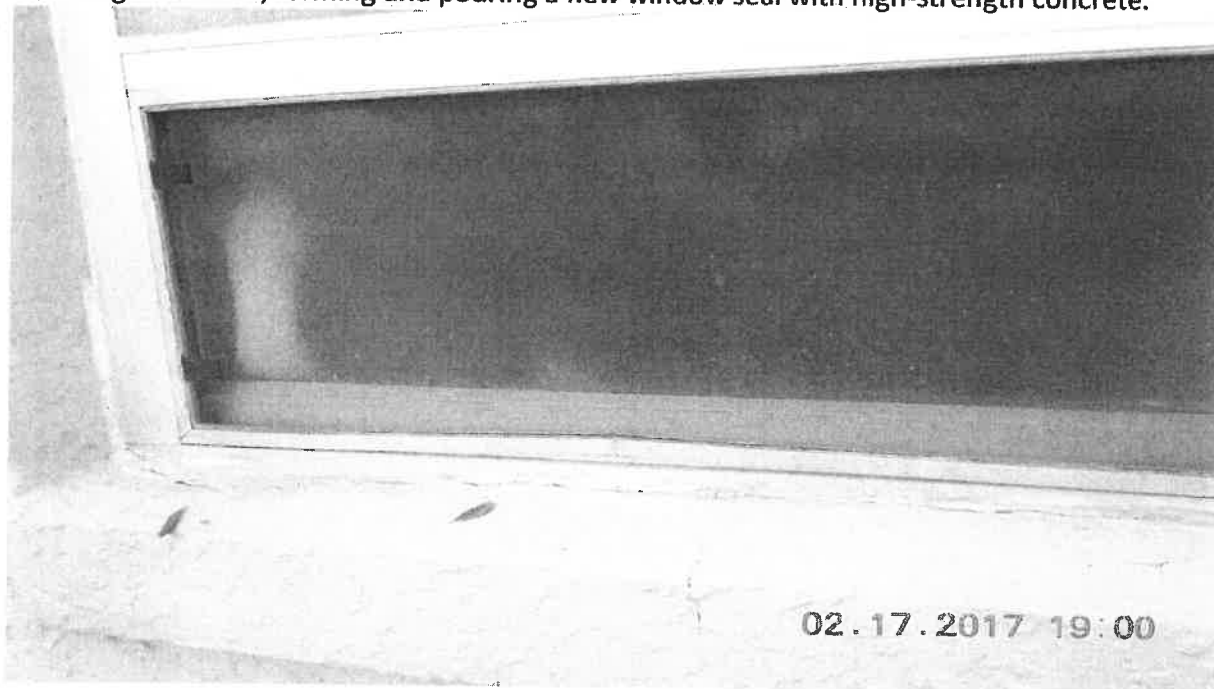
Repair unit # 9, window seal this will require completely removing the existing window seal installing new rebar, forming and pouring a new window seal with high-strength concrete.

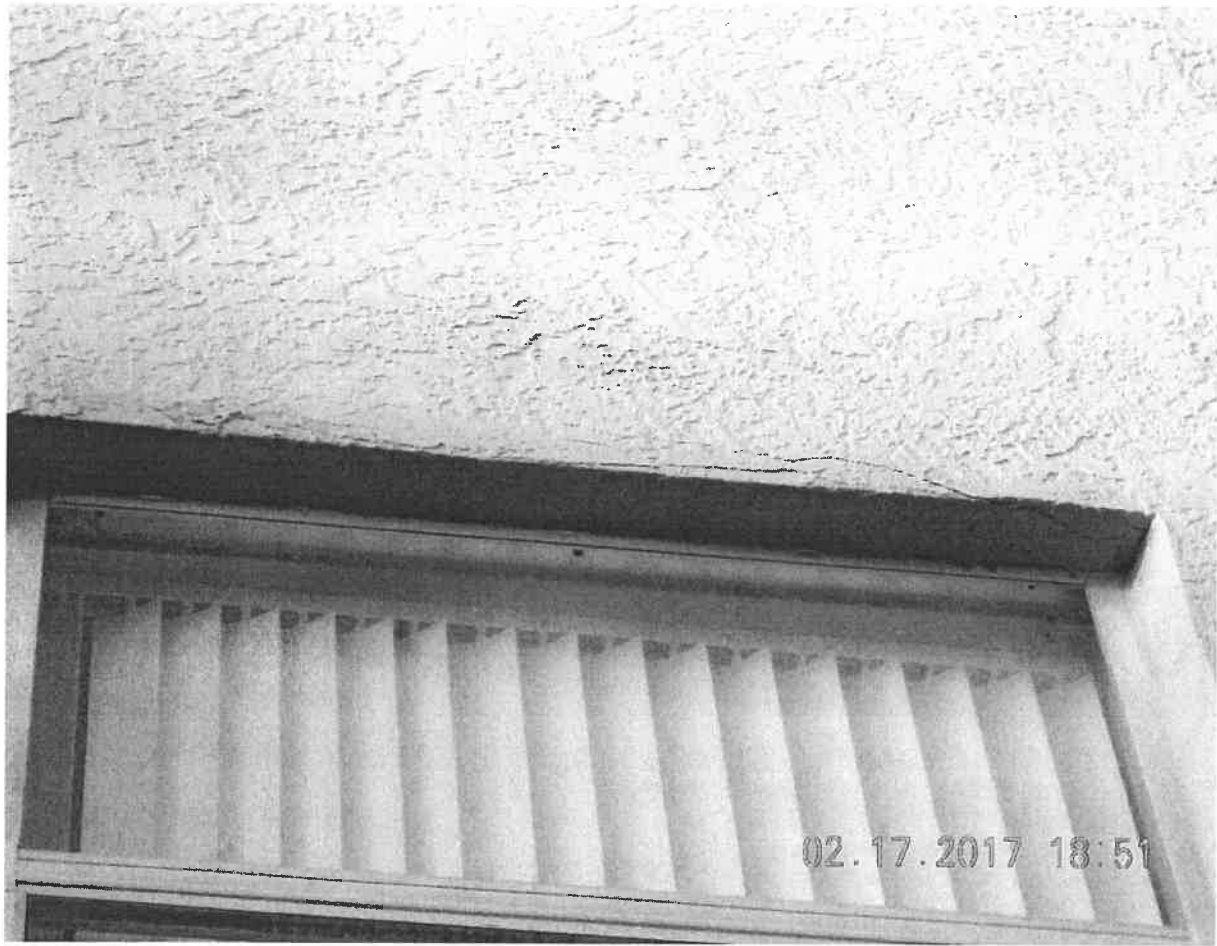
Header repair unit 3, all of the cracks have to be investigated which requires chiseling out the concrete to the rusted rebar areas causing the spalding/cracking which has been clauked and pached. Replacing the rebar and/or coating it with a rust inhibitor and installing new high-strength concrete, texturing and matching stucco as close as possible priming and painting. This may require replacing the window.

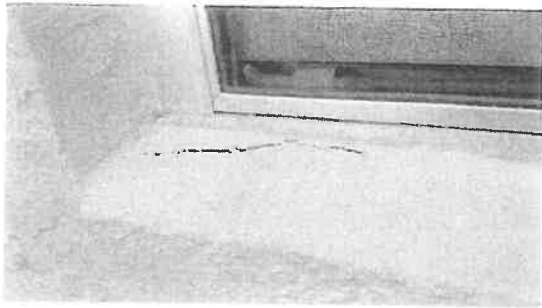
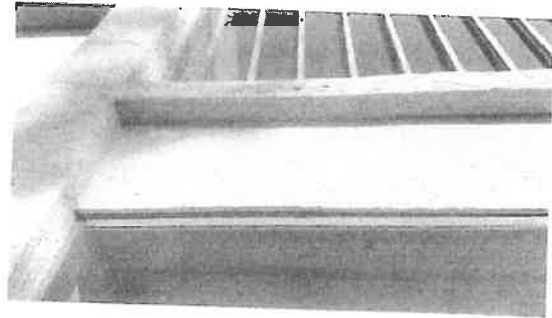
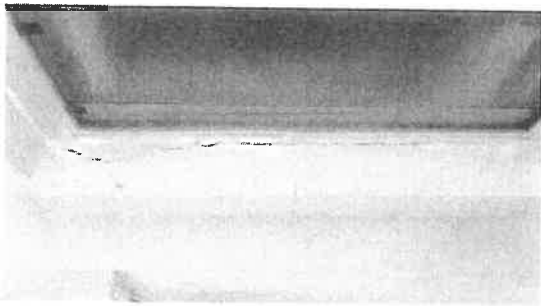
Unit#8 one photo balcony needs patch

Unit#8 two photos bathroom window sill needs replacing

Unit#6 one photo bathroom window sill needs replacing

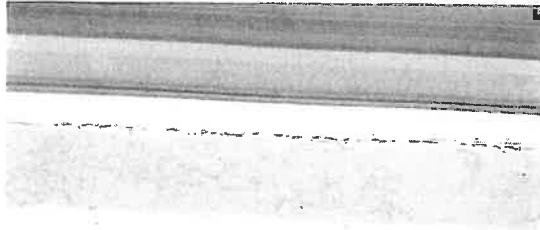
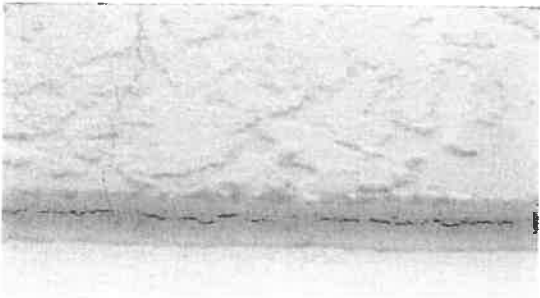
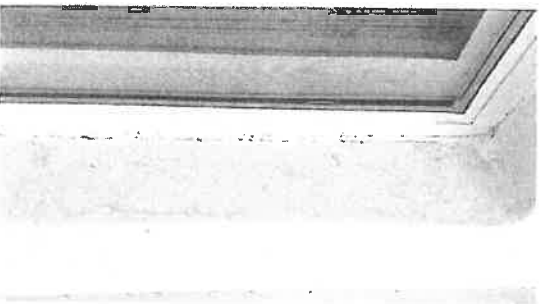
Unit # 8 two photos  
Unit # 5 three photos  
Window sills need to be repair  
Recaulk all windows

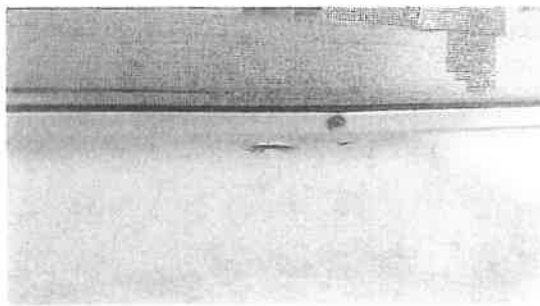
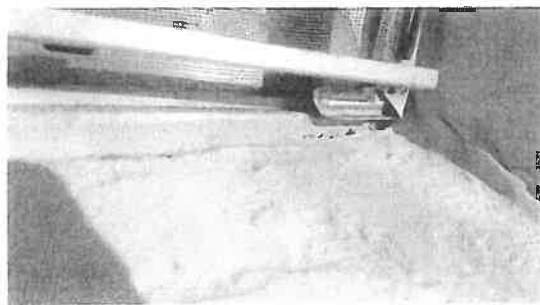
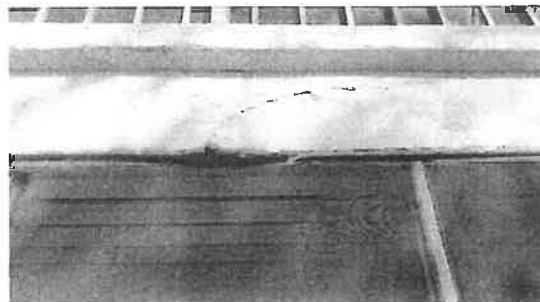
Unit#6 two photos kitchen window sill needs replacing  
One photo North window needs recaulk  
One photo balcony header needs replacing

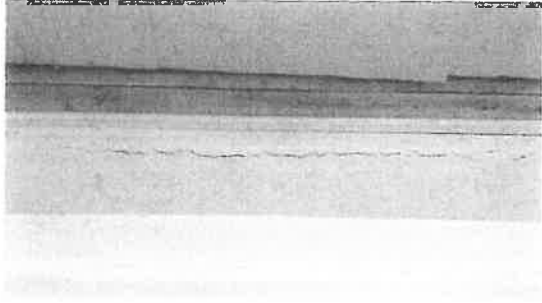
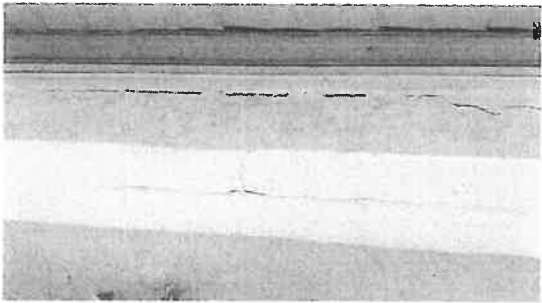
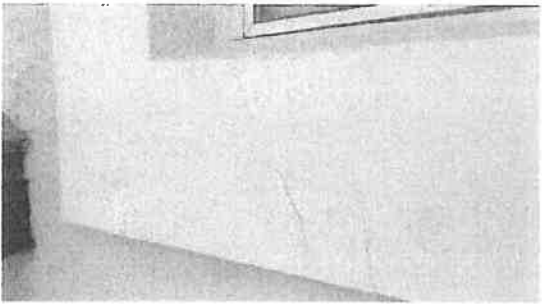
Unit#5 two photos two lower Windows sills hollow and crack need to be repair  
Unit#2 same situation

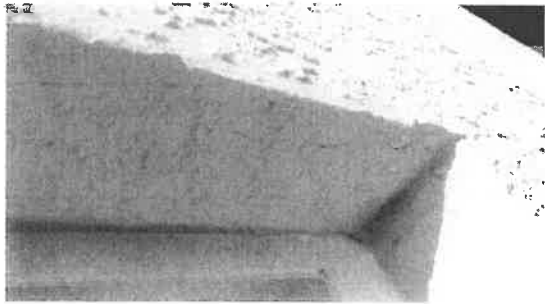
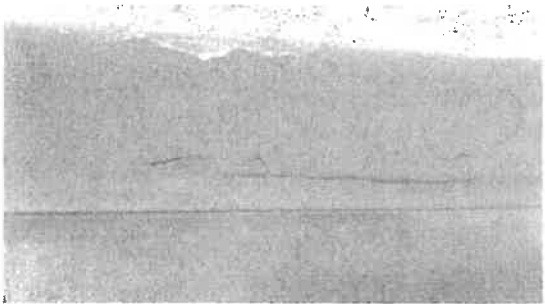
Unit#3 two photos bathroom window header needs repair and masterbedrm window sill also  
Unit#1 two photos bathroom window patch by others aready cracking  
Master bed caulk by others needs recaulk again

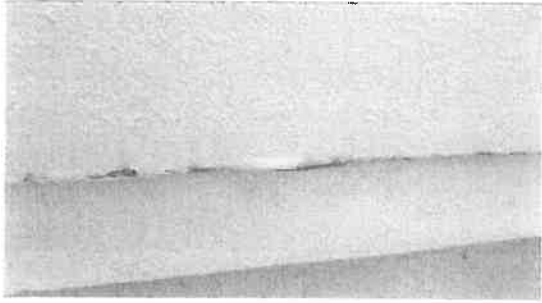
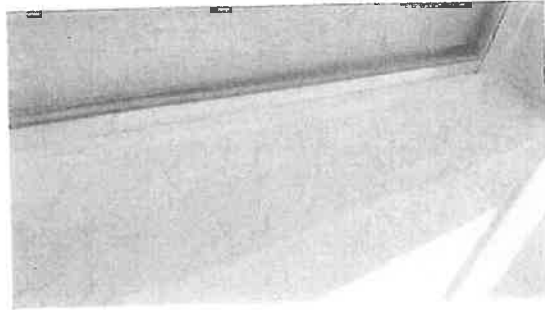
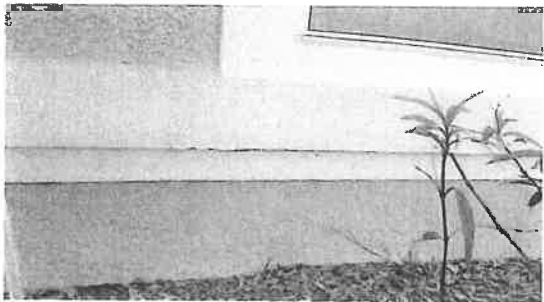
- Unit#4 two photos one photo upper window sill and band crack need replacing
- Unit#3 one photo front right window need caulk
- Unit#3 front left window need replacing
- Unit#1 section of stucco band needs replacing with plastic bead
